# A STUDY ON CORROSION MECHANISM OF FBR STRUCTURAL MATERIAL IN SMALL SODIUM LEAK UNDER INSULATOR

*T. FURUKAWA (1), D. PIAT (2), S. ROSANVALLON (2) and C. LATGE (2)*

**Key words:** Corrosion, Sodium leak, Structural material

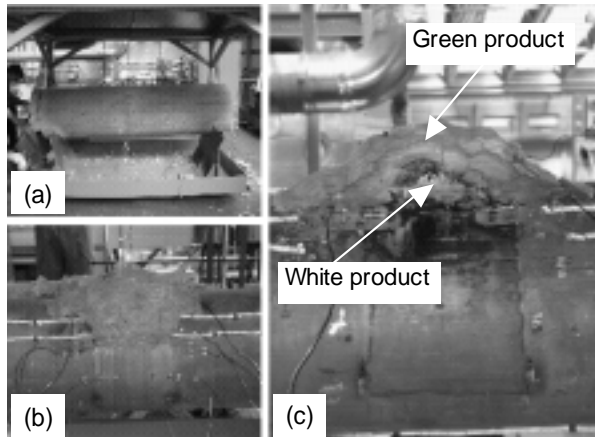
Fig. 4 The photograph of the mock-up

The photographs of the pipe after the test are shown in figure 4. Although discoloration owing to high temperature heating was observed on the surface of the insulator, leakage sodium was not observed (figure 4(a)). Green product was deposited on the pipe removed from the insulator, with a dimension of about 400 mm wide and 90 mm high (figure 4(b)). From this finding, it was considered that most of the leakage sodium was held within the product. The cross-section of the product is shown in figure 4(C). Semi-lustrous white product was observed inside the green product, and black one at the interface of the white layer and the pipe.

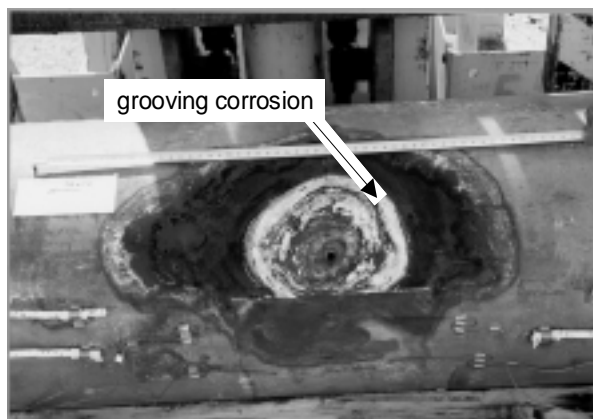
Fig. 5 The appearance of the pipe after water cleaning

Photographs of the pipe following water cleaning and of the pipe thickness are shown in figure 5 and 6. Three differential phenomena prevailed on the surface. The color of the inner region located under the white product was brown with partial gray, and the corrosion depth was less than 0.7 mm. The outer region located under the green product was blackish brown, and the depth was the same as that of the inner region. Concentric grooving corrosion of maximum depth 2.1 mm was observed between the two regions. The width was about 20mm, and the appearance was silver metallic with luster. There was an insignificant amount of corrosion product on the spot. Only NaFeO<sub>2</sub> and NaOH were identified in the product by X-ray analysis. In short, it was considered that the chemical reaction in Na-Fe-O system occurred in the area.

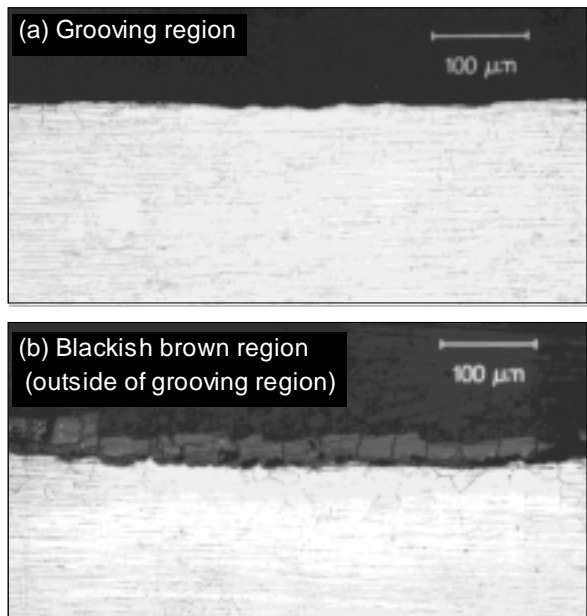
Fig. 7 Observation results of the pipe

The results of optical microscopy of the cross section and scanning electron microscopy of the surface are shown in figure 7 and 8. It was proven that although oxide was found

in the outer region, none was observed in the grooving region. Furthermore, general corrosion prevailed without ruggedness.

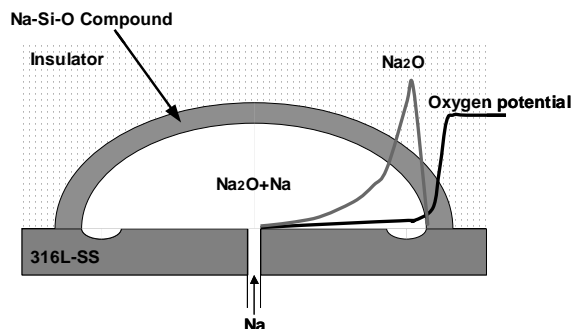
Fig. 10 Reaction phenomenon under insulator

The width of the grooving corrosion was greater than that of other cases which were reported by Bertrand et al. It was considered that the width might have a relationship with

the sodium leak ratio. Since this corrosion took place at  $\text{Na}_2\text{O}$  highest activity, the moving rate was based on the leak rate (figure 10).
