PHENIX OPERATION FEEDBACK AND APPLICATION FOR THE FUTURE.

J GUIDEZ Director of Phenix plant from November 2002 to december 2007

Lecture at Tsuruga , the 28th August 2009

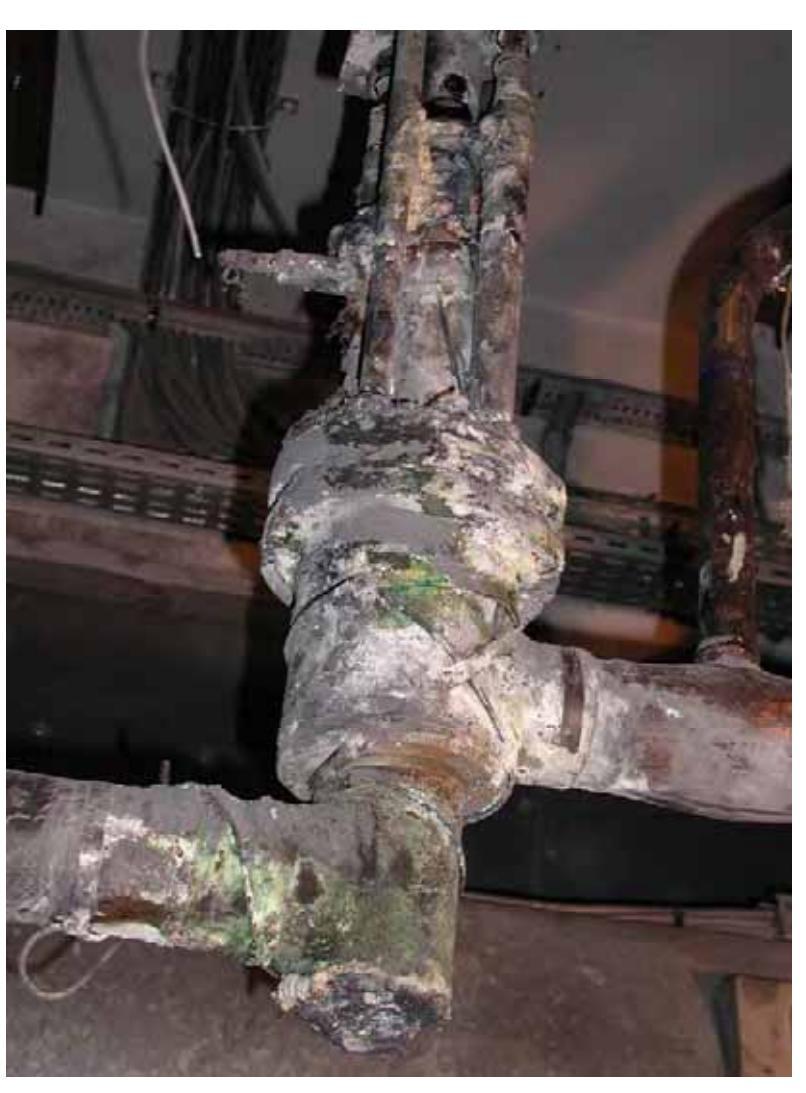
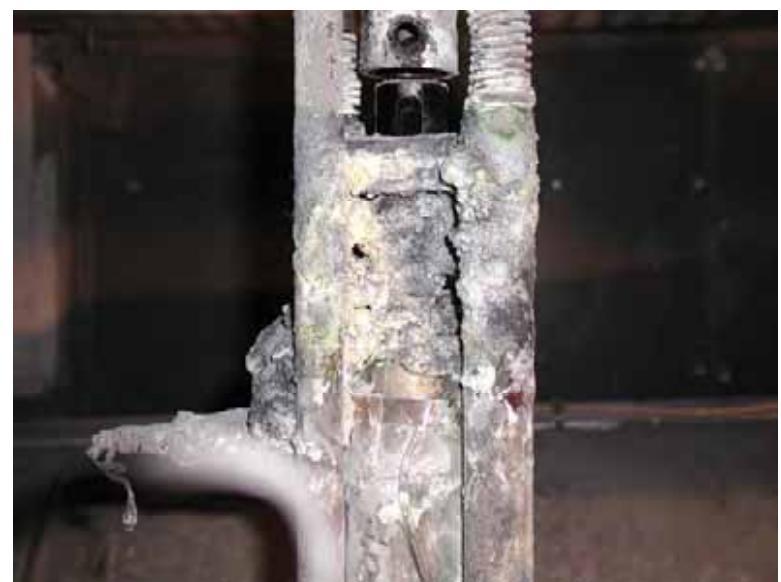
SODIUM LEAK on PURIFICATION LOOP n°1 (March 2003)

Disassembling of the leaking valve

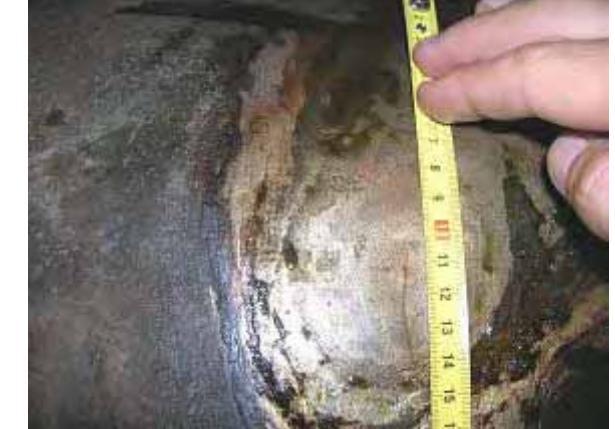
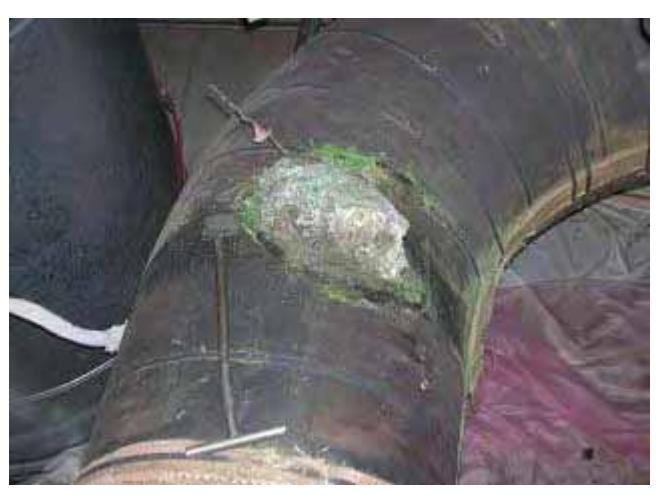
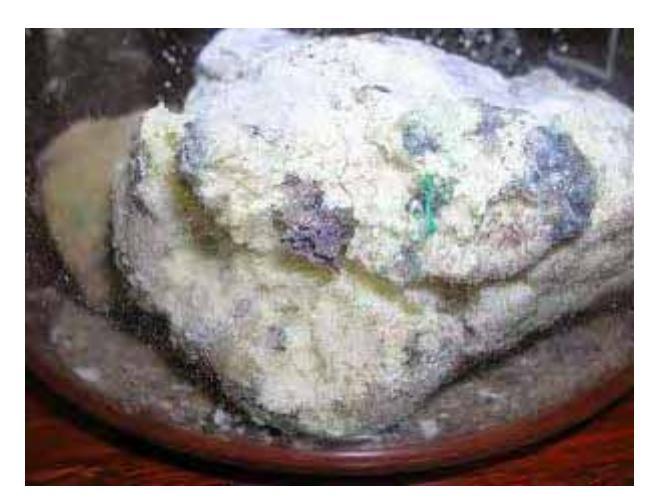
AN EXAMPLE OF SODIUM LEAK (21st August 2007)

- Amount of leak : approximately 1kg, confined in the insulation
- No corrosion found on piping

- Metallurgical examination: crack in a zone repaired in 1997
- Cause: creep cracking due to local stress induced by repair

Solid Compound: sodium and insulation material

Replacement of the elbow and straight part of piping

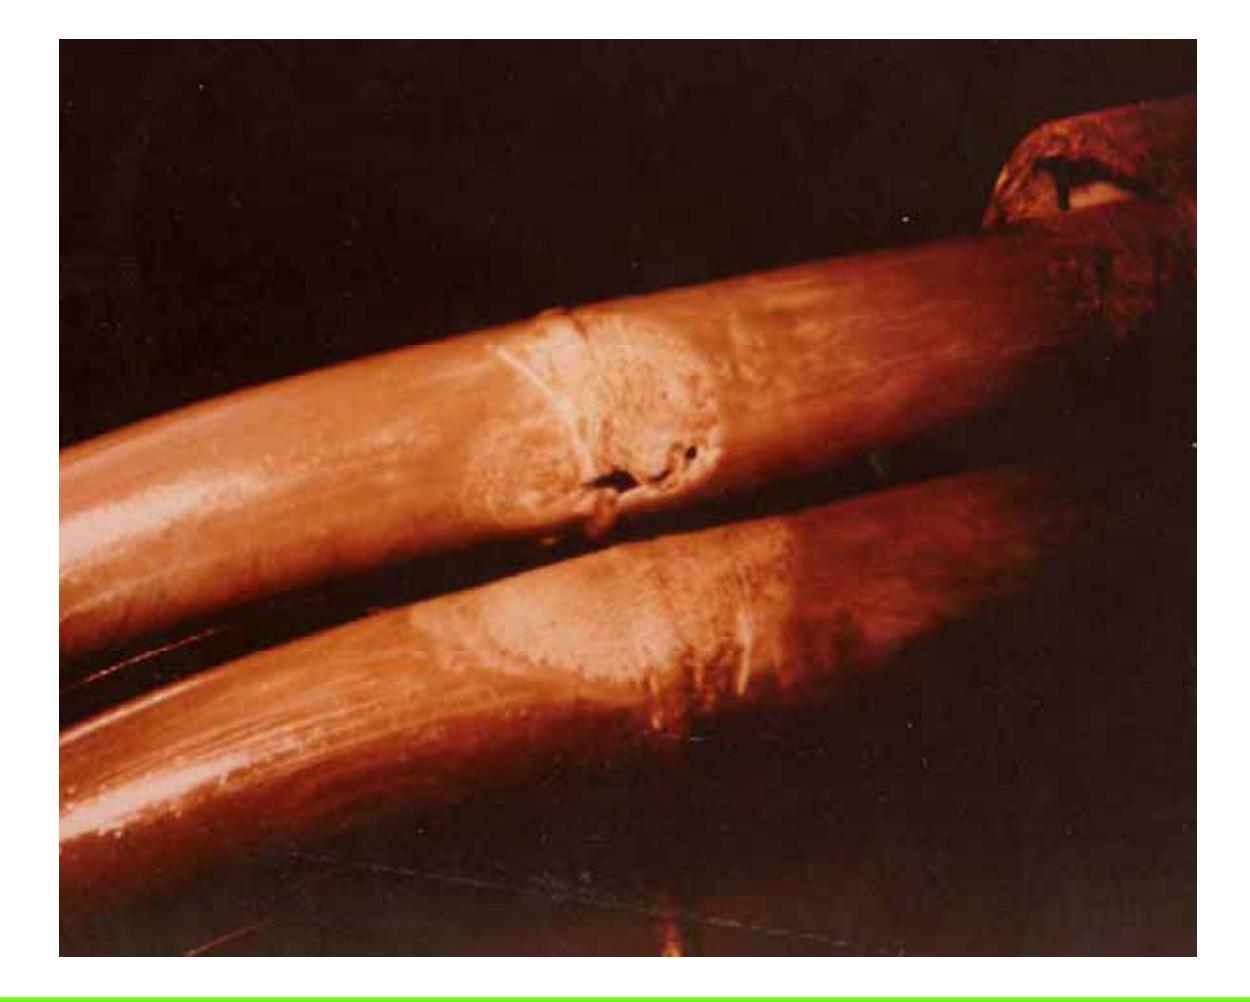
Sodium-water reactions: April 1982 event

Cause: fatigue damage due to temperature fluctuations during start up phase (water ingress)

Steam tubes of SG2 reheater module n°12

All reheater units replaced

Improvement of startup procedure, Leak detection and Shutdown sequence

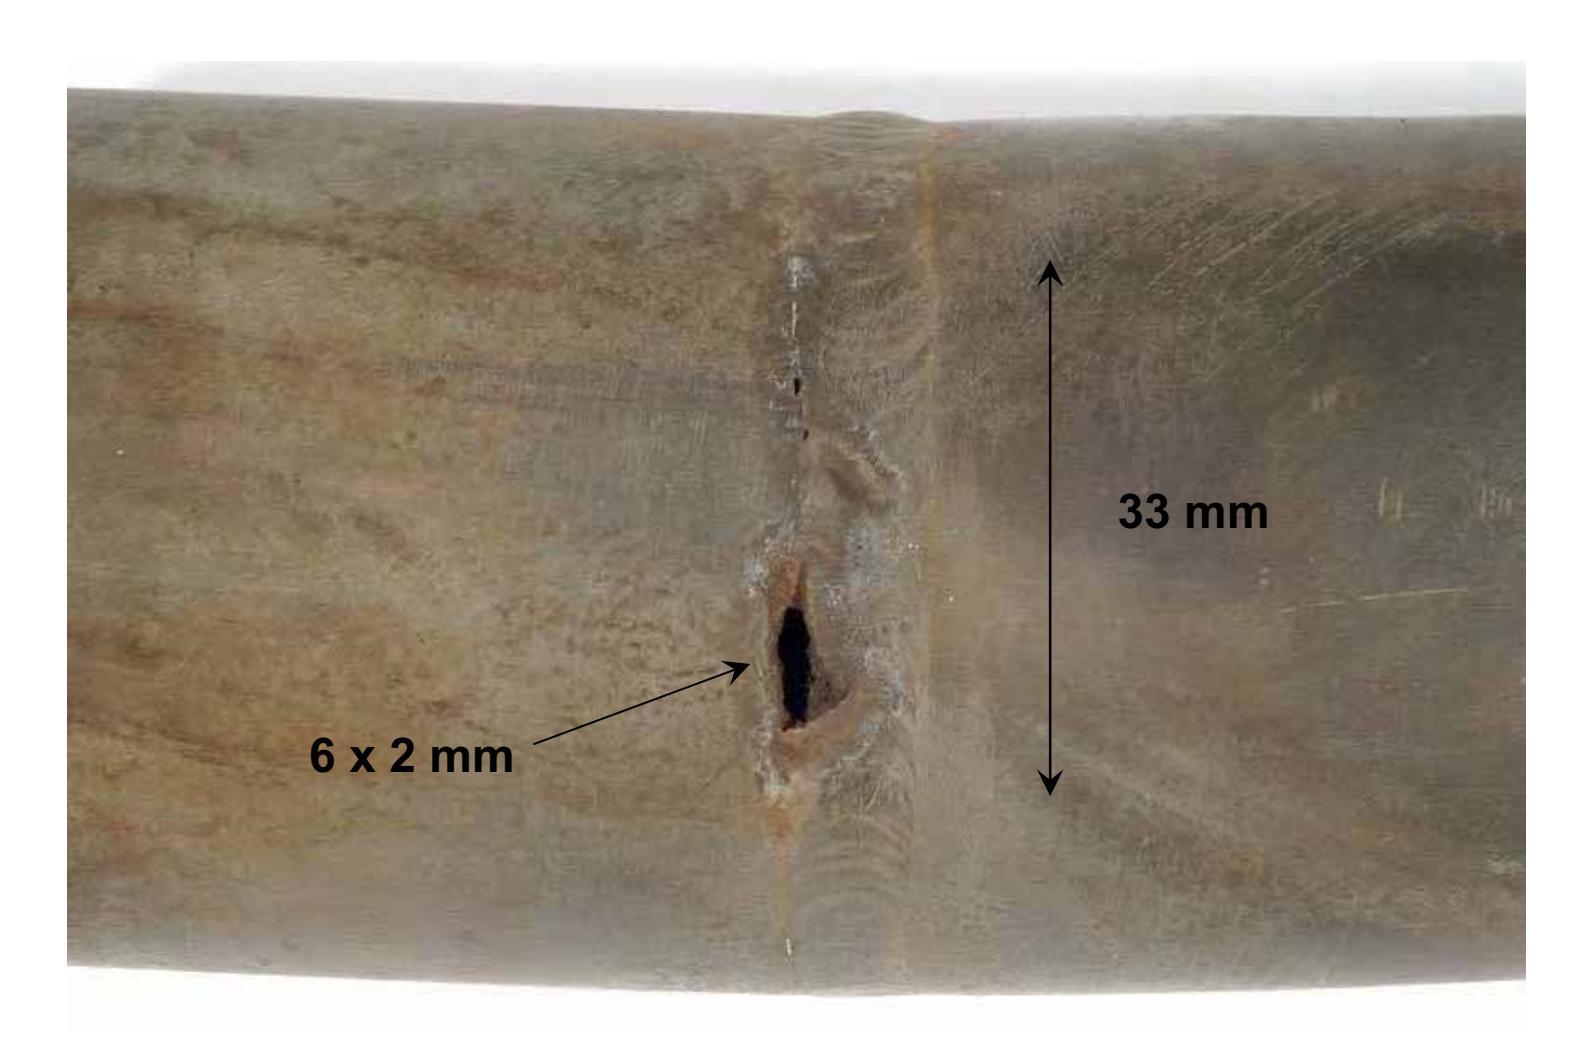
Sodium-water reactions: Sept. 2003 event

Cause: welding defect on one reheater steam tube Replacement of the module

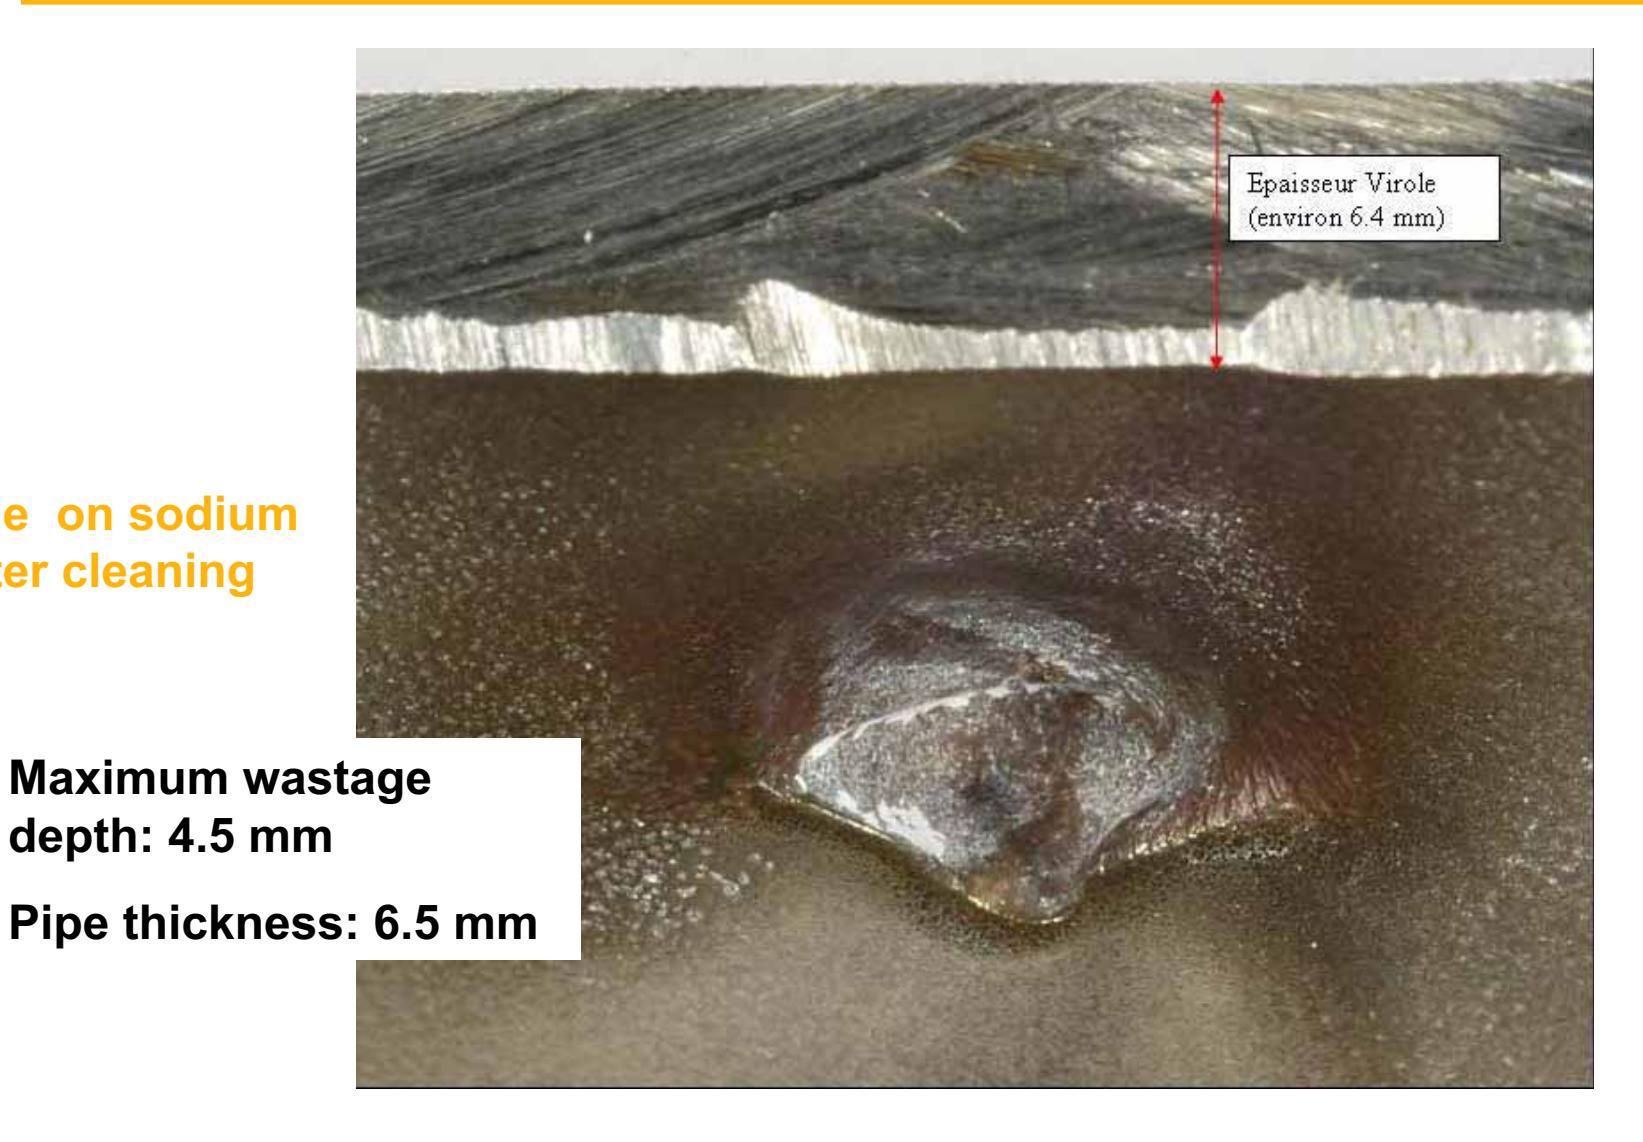
Sodium-water reactions: Sept. 2003 event

Wastage on sodium pipe after cleaning

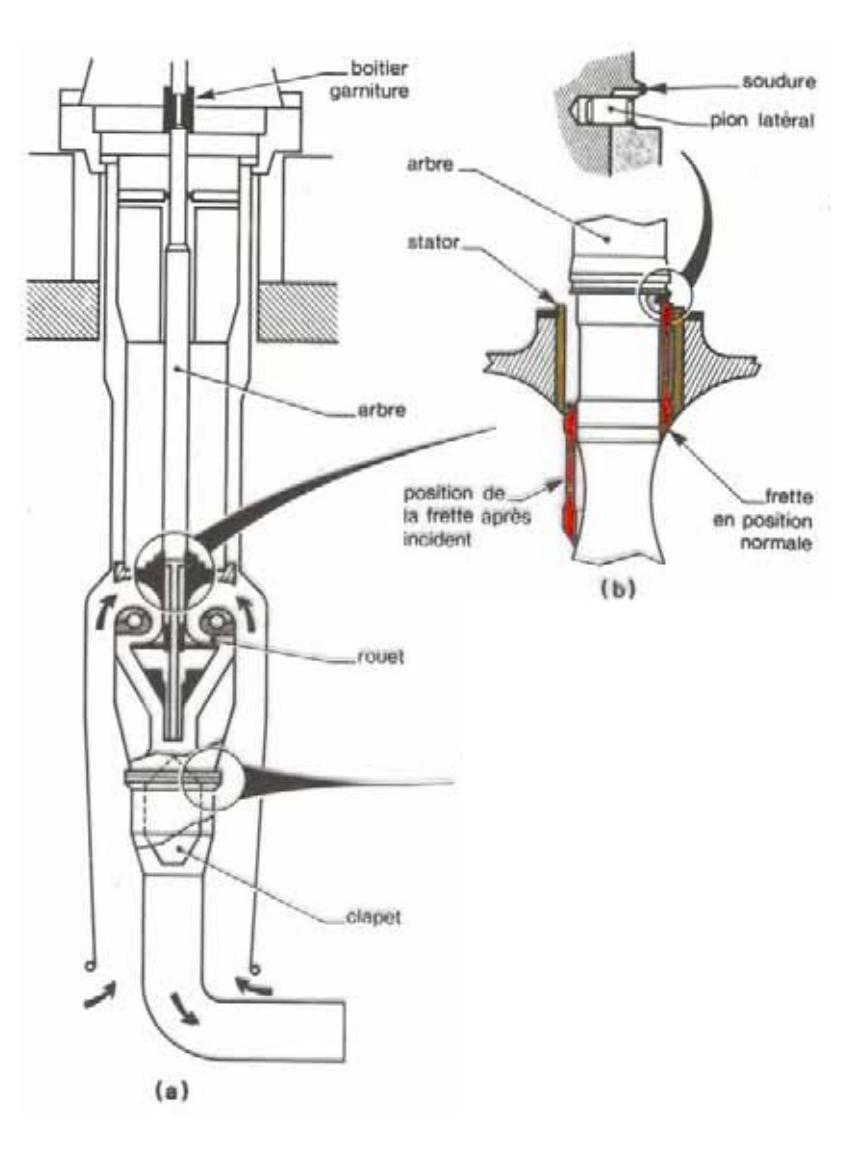
Hydrostatic bearing of pumps

slippage of reinforcements from hydrostatic bearing

Incidents in 1976 and 1981 on the primary pumps, and in 1987 on a secondary pump. Reinforcements slid down to the level of the pump impellers.

> ✓ Mechanical incidents due to repeated expansion and contraction on the braces after the sodium thermal cycles during the trip transients.

✓ Modification in the assembly of all the pump reinforcements

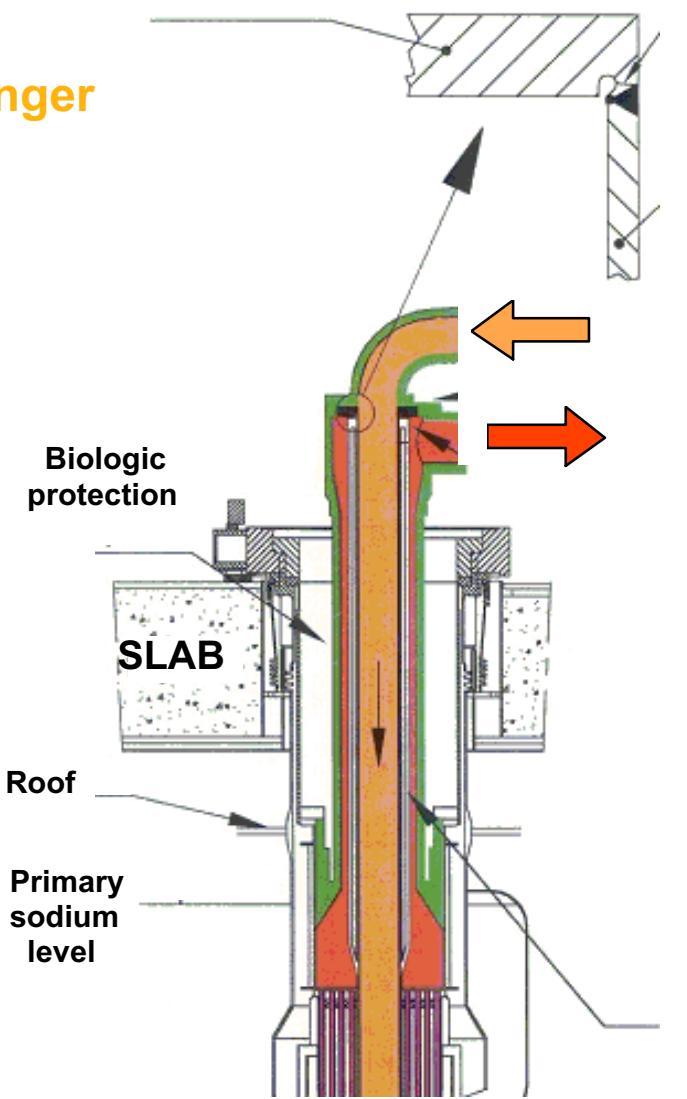
Events in 1976/1977 on all intermediate heat exchangers(1)

- this plate connects the 2 shells forming the secondary sodium header
 - difference of temperature arising between the 2 shells led to differential expansion between these shells
 - this gave rise to high mechanical stresses and caused the weld connecting the inner shell to the plate to crack

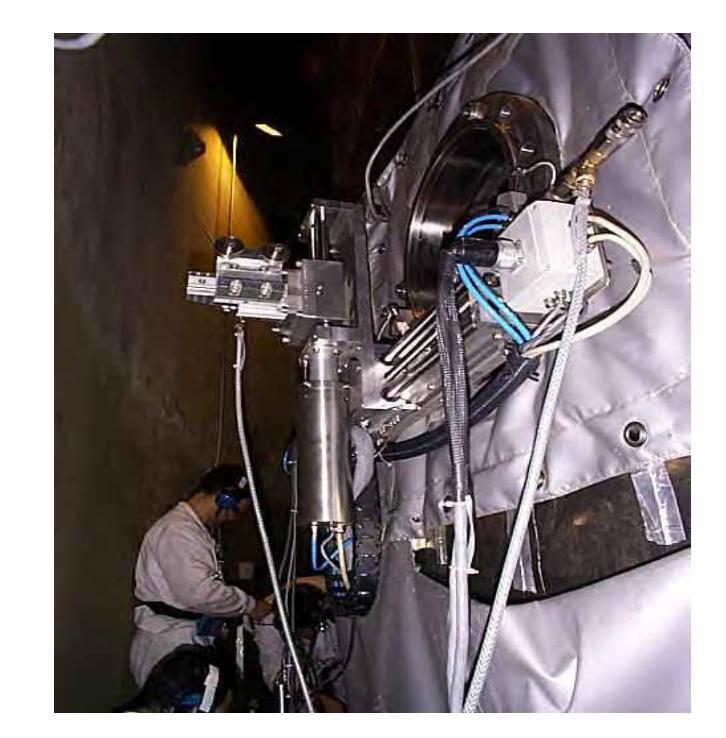
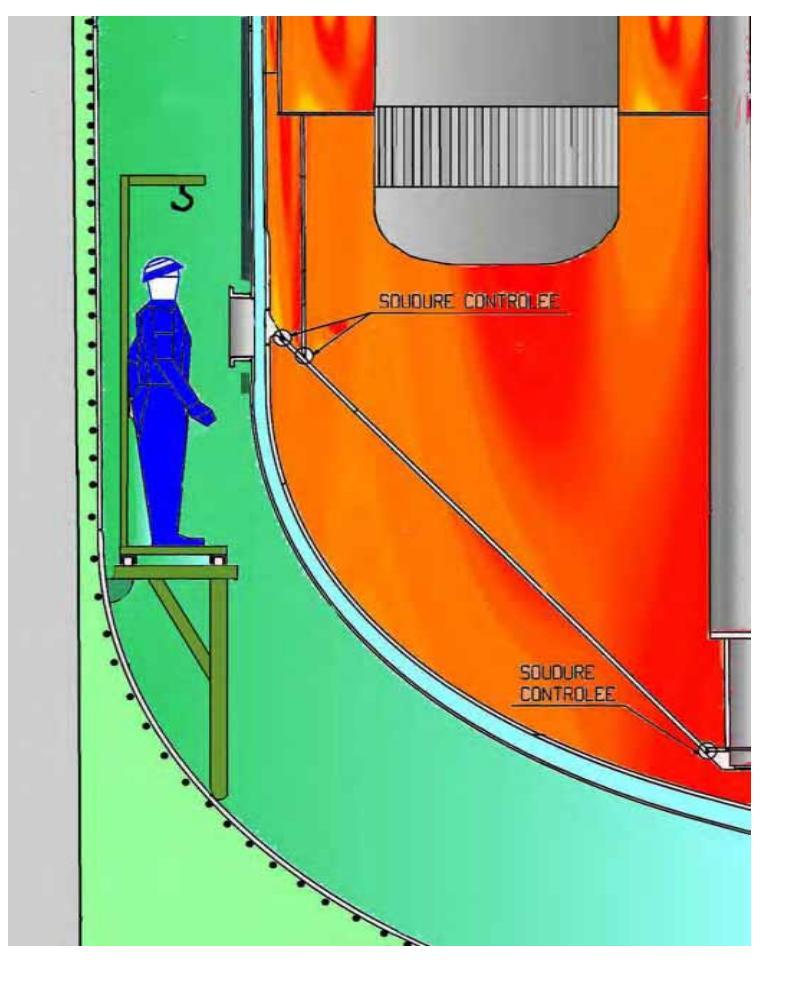
SPECIAL INSPECTIONS of REACTOR INTERNALS

Ultrasonic inspection of the core support conical skirt carried out under sodium at 155 °C Sept-Oct 1999

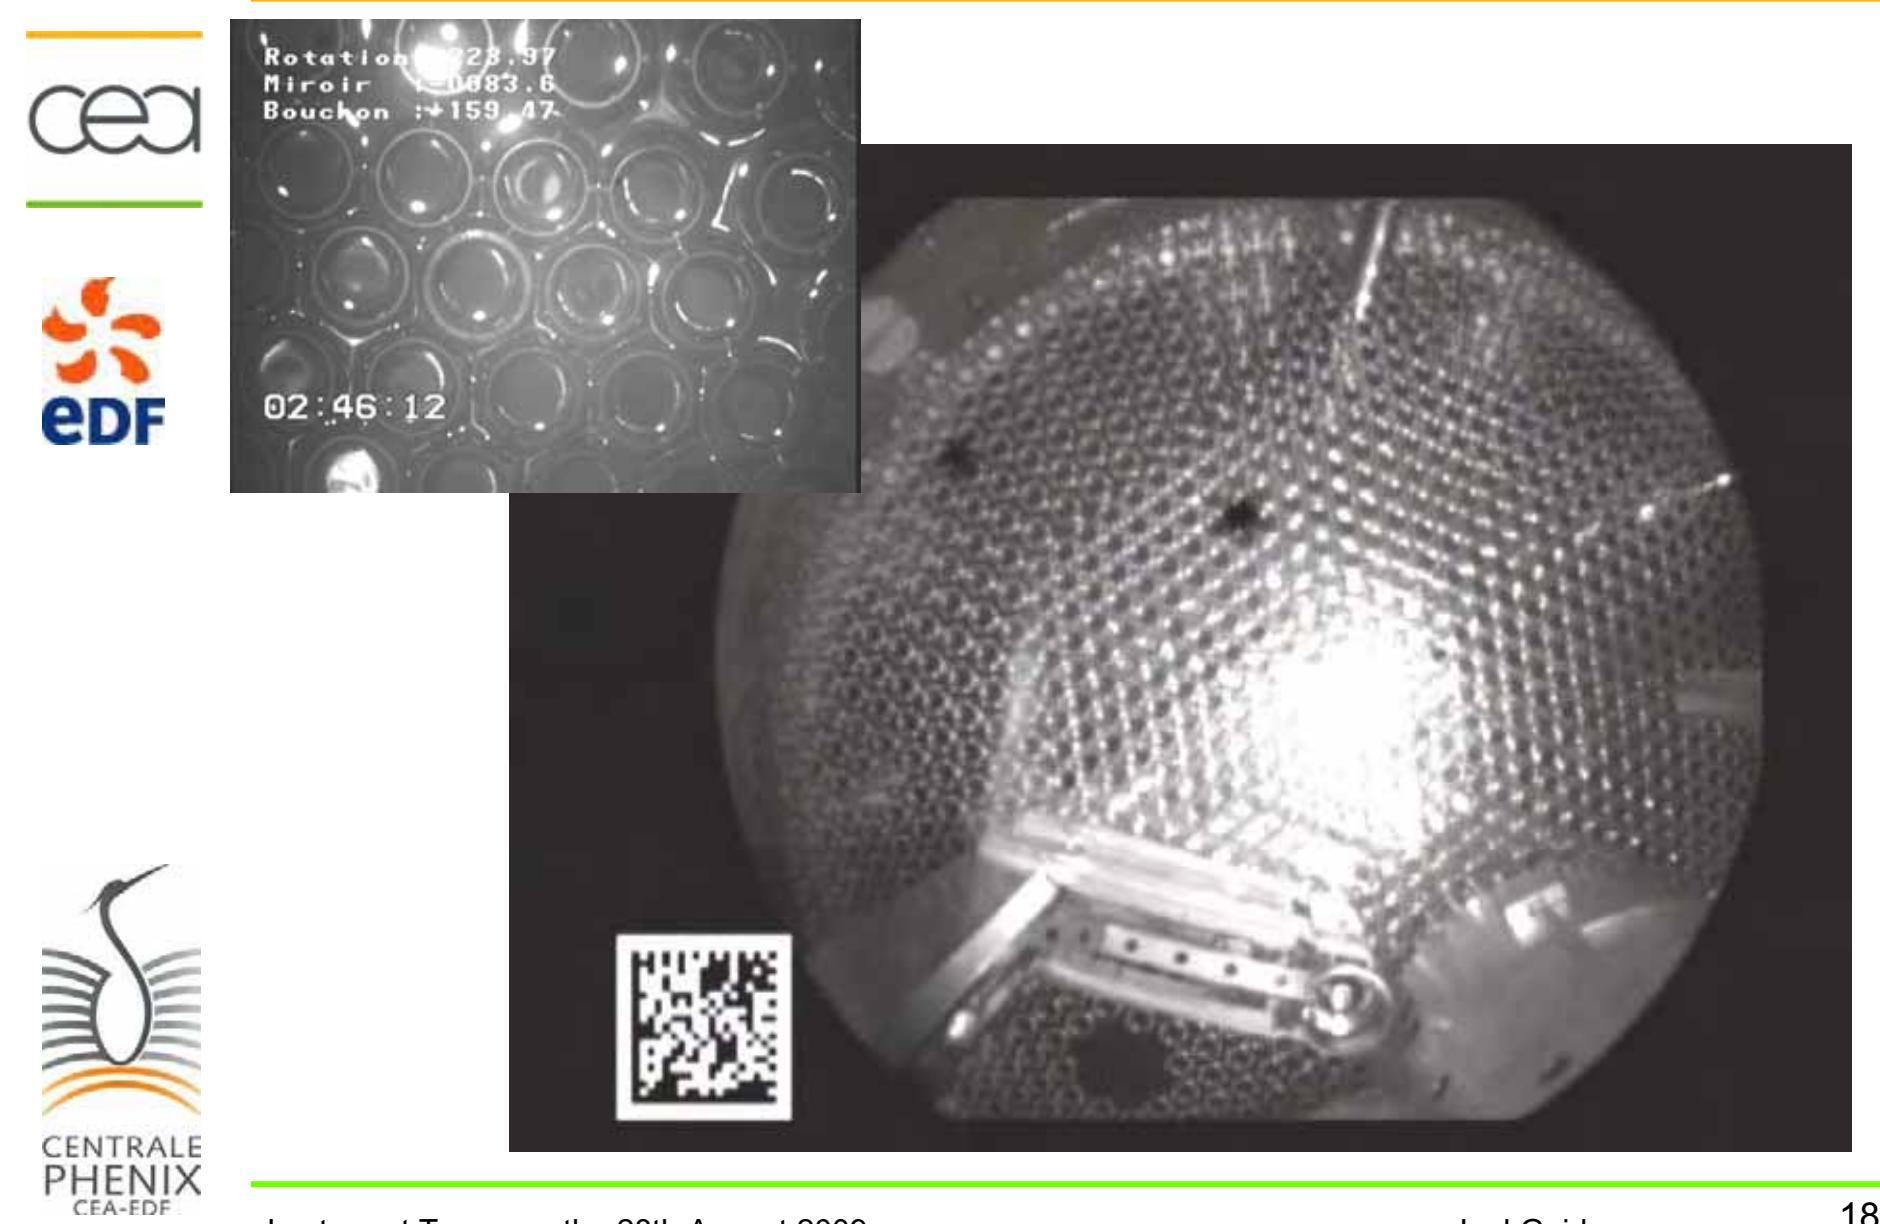
CORE S/A HEADS

A visual inspection of the core cover plug and of the internal structures was made in March-April 2001 For this operation sodium was drained partially from the reactor block , ans special devices allow to provide lights and visualisation
