# A STUDY ON CORROSION MECHANISM OF FBR STRUCTURAL MATERIAL IN SMALL SODIUM LEAK UNDER INSULATOR

*T. FURUKAWA (1), D. PIAT (2), S. ROSANVALLON (2) and C. LATGE (2)*

**Key words:** Corrosion, Sodium leak, Structural material

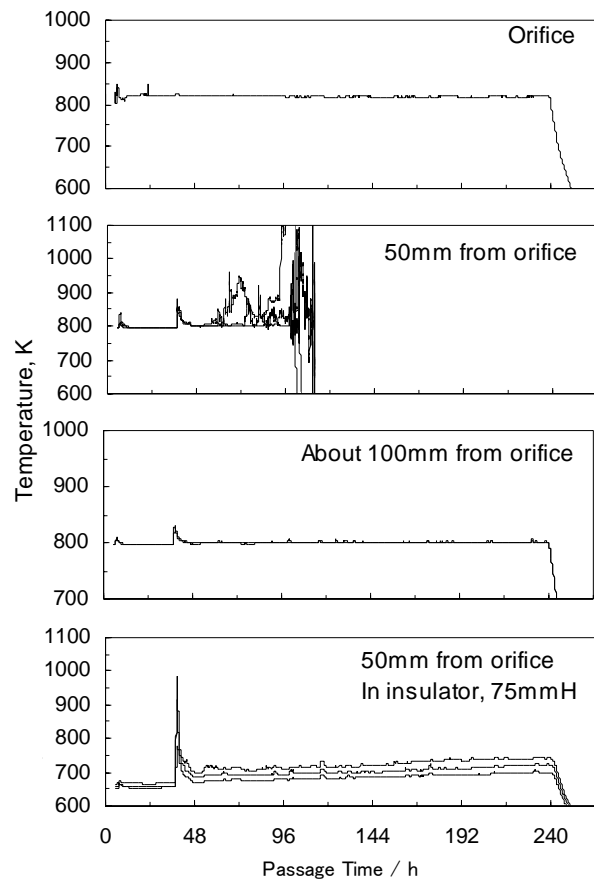
Fig.3 Temperature behavior

The temperature behaviors in the vicinity of the orifice throughout the test period are illustrated in figure 3.

According to the output of the thermocouple set up in the orifice, the temperature rise which was apparently resulted from the interaction between sodium and oxygen, had been observed starting from leak initiation ( $T_0$ )

for 14 hours. The temperature eventually kept at 818K.

The temperatures of the three thermocouples mounted on the pipe at a distance of 50 mm from the orifice, sharply fluctuated in the range between 793K and 973K before these thermocouples failed. In this region, grooving corrosion with luster was observed (ref. next chapter). The temperatures of other thermocouples installed on the pipe were maintained at approximately 818K during the test period, excluding  $T_0+38$  hours to  $T_0+40$  hours. Based on the data from the thermocouple placed in the insulator, the temperature fluctuation, which seemed to be due to the chemical reaction between leakage so-

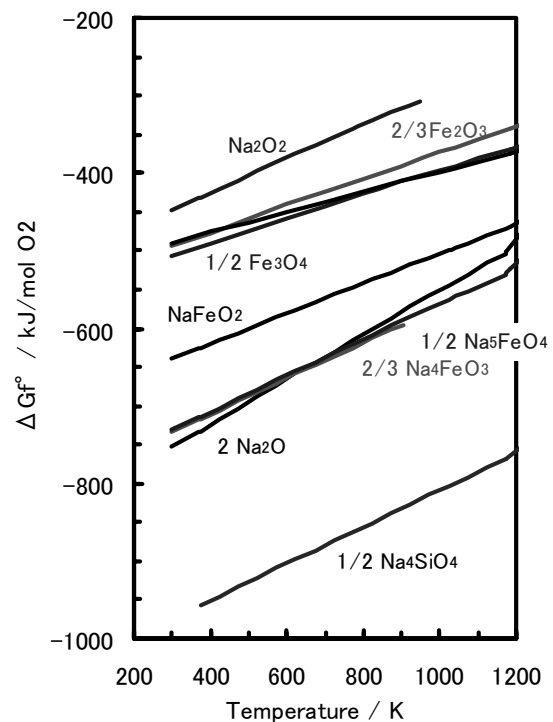
Fig. 9 Comparison of the standard free energy of iron oxide formation

Grooving corrosion was observed between the two regions. On the surface, Na-Fe complex oxide was noted but none of iron oxide. The reason can be explained by the comparison of the standard free energy of iron oxide

formation with that of other oxides as shown in figure 9. Although  $\text{Na}_2\text{O}$  does not oxidize the steel (iron), it is possible for oxidation to occur through the formation of Na-Fe complex oxide. In brief, the chemical reaction of  $\text{Na}_2\text{O}$  and Fe might have prevailed in this area. Aoto et al. [5] has reported the same phenomenon with regard to the corrosion test in Na+ $\text{Na}_2\text{O}$  environment, and named it the 'NaFe double oxidation type corrosion'. In short, Na and  $\text{Na}_2\text{O}$  were considered to form in the region.

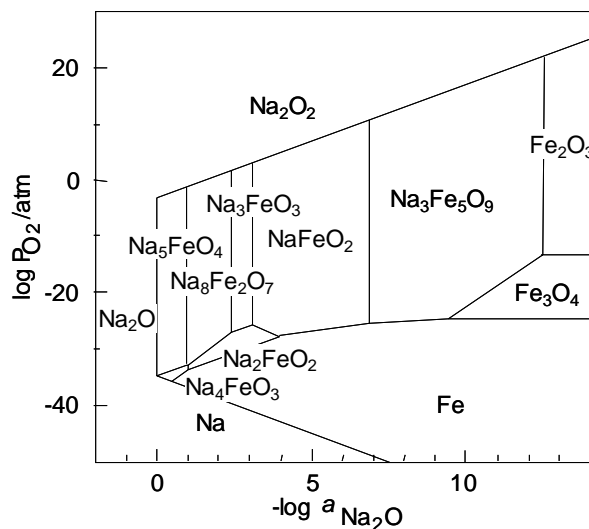
Fig. 11 Chemical diagram in Na-Fe-O system at 873K

The chemical diagram of Na-Fe-O system is shown in figure 11.  $\text{Na}_4\text{FeO}_3$  is formed in  $\text{Na}_2\text{O}$  and Na environment. It has been confirmed that the compound melted at about 923K [8]. Moreover, the corrosion rate in  $\text{Na}+\text{Na}_2\text{O}$  at temperature less than 923K was lower than the value of the average line based on the results over 973K [5]. In other words, the corrosion rate was limited by the diffusion step through layer of  $\text{Na}_4\text{FeO}_3$ , which was present in solid state below the melting point (about 923K).

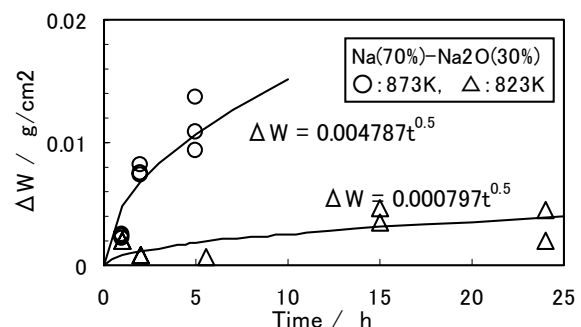
Fig. 12 Corrosion test results in  $\text{Na}+\text{Na}_2\text{O}$

The results are indicated in figure 12: the average lines were based on parabolic law (see equations in the figure). It is clearly shown that metal loss could be predicted

based on the time dependence and that the rate was limited by the diffusion law.
